**DEPARTMENT OF TRANSPORTATION****DIVISION OF ENGINEERING SERVICES**

Office of Structural Materials

Contract #: 04-0120F4Cty: SF/ALA Rte: 80 PM: 13.2/13.9File #: 69.28**WELDING INSPECTION REPORT****Resident Engineer:** Pursell, Gary**Address:** 333 Burma Road**City:** Oakland, CA 94607**Report No:** WIR-004635**Date Inspected:** 29-Oct-2008**Project Name:** SAS Superstructure**OSM Arrival Time:** 700**Prime Contractor:** American Bridge/Fluor Enterprises, a JV**OSM Departure Time:** 1700**Contractor:** Zhenhua Port Machinery Company, Ltd (ZPMC), Changxing Island **Location:** Shanghai, China**CWI Name:** Sun Wei**CWI Present:** Yes No**Inspected CWI report:** Yes No N/A**Rod Oven in Use:** Yes No N/A**Electrode to specification:** Yes No N/A**Weld Procedures Followed:** Yes No N/A**Qualified Welders:** Yes No N/A**Verified Joint Fit-up:** Yes No N/A**Approved Drawings:** Yes No N/A**Approved WPS:** Yes No N/A**Delayed / Cancelled:** Yes No N/A**Bridge No:** 34-0006**Component:** Tower**Summary of Items Observed:**

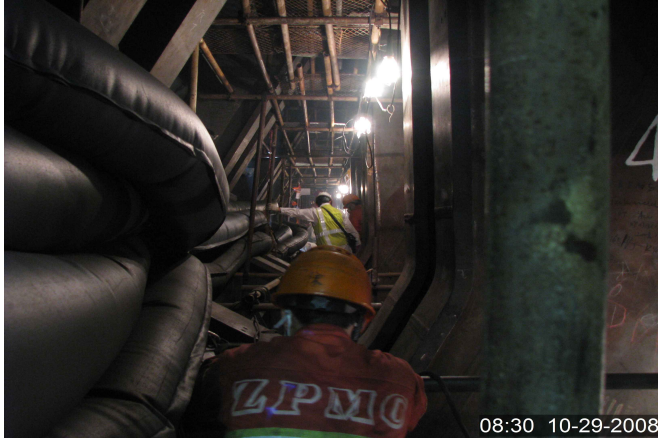
ZPMC observed fitting up and tack welding Skin C to the diaphragm plates and in the process of welding temporary fitting aids to Skin C where it joins with skin D. (Skin D was erected yesterday evening 10-28-09. Approximately 5 ZPMC employees were in the confined space. An ABF safety employee was present at the badge tracking board and stated know one with ABF would enter the confined space for two to three days.
